## RESERVE STUDY REPORT

### **Gold Standard Homeowners Association**

**Date Prepared: June of 2019**

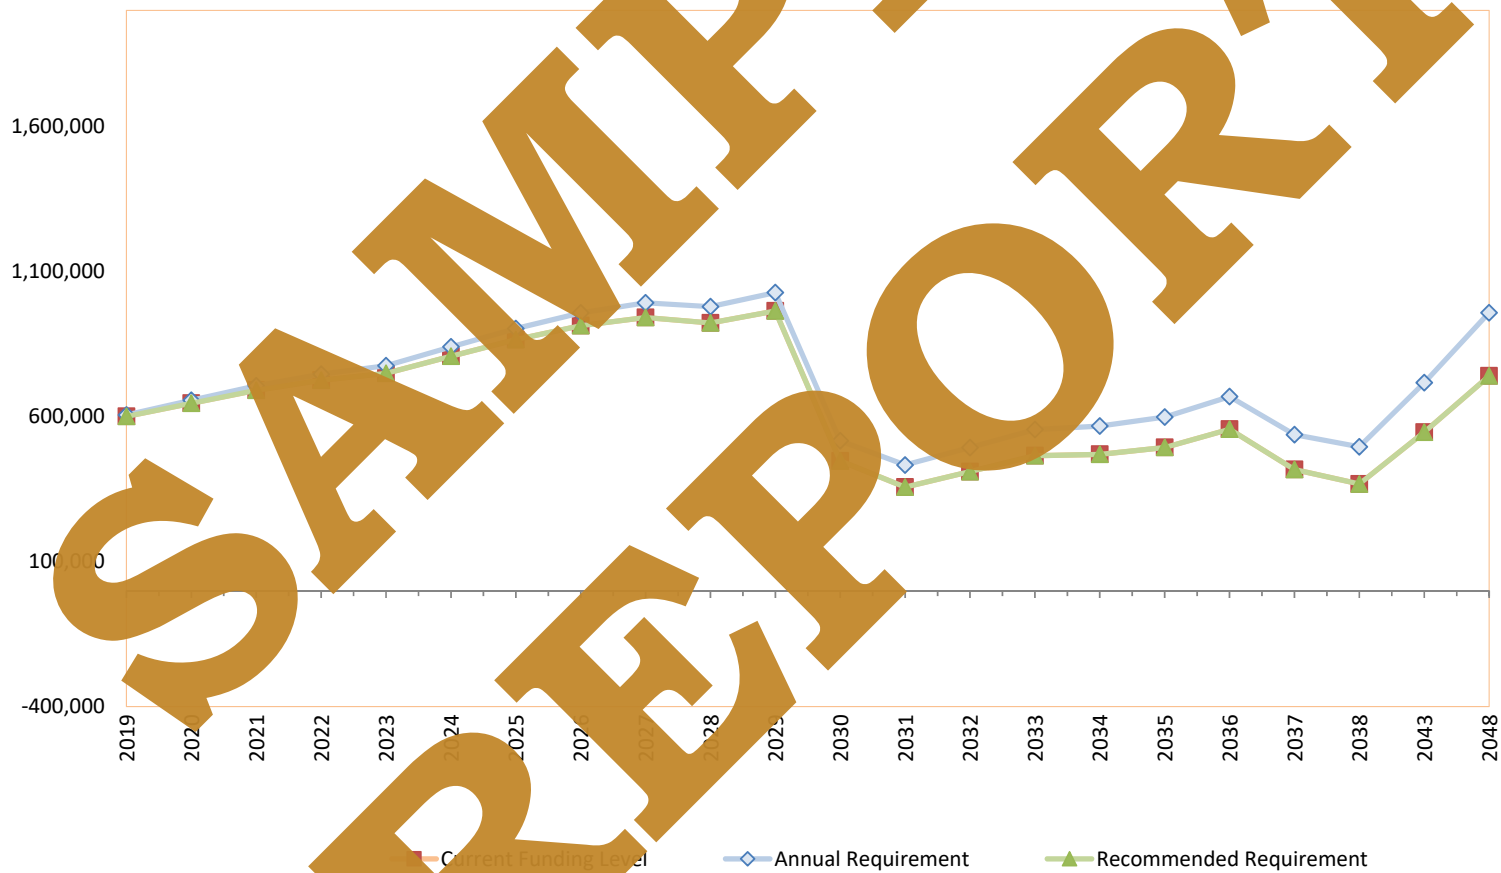
CHART EXHIBIT RELATING TO PROJECTIONS

Year-End Reserve Balances  
Projected over 30 Years

OPTION 3 - RECOMMENDED FUNDING: Current Regular Reserve allocations should adequately fund reserves with no deficits.
